# Site Description

The site is located at 300 Taylor Street in Dayton, Ohio. The current-day site comprises approximately 22 acres. The site is bordered by vacant parking lots to the south, the Mad River to the north, Keowee Street and the City of Dayton Water Plant to the east, and Webster Street and a vacant parking lot to the west.

PRC Environmental Management, Inc. (PRC) received Work Assignment No. C05087 from the U.S. Environmental Protection Agency (U.S. EPA), under Contract No. 68-W9-0006 (TES 9), to conduct preliminary assessments (PA) and visual site inspections (VSI) of hazardous waste treatment and storage facilities in U.S. EPA Region 5.

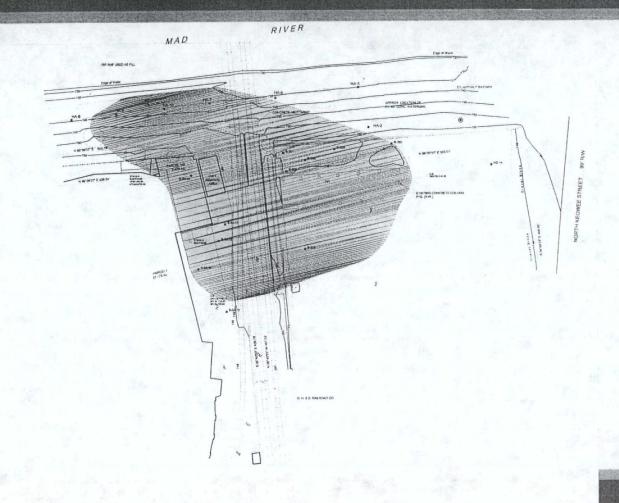
# -Free Product Plume Map

Installed soil borings and sampled existing monitoring wells on the site and also on Miami Conservancy District (MCD) property (soil borings only) which confirmed presence of oil contaminated with PCBs at water table interface. Concentrations of detected PCBs in free product ranged from 174 mg/kg up to 1330 mg/kg. PCBs in soils ranged from non-detect up to 3250 mg/kg

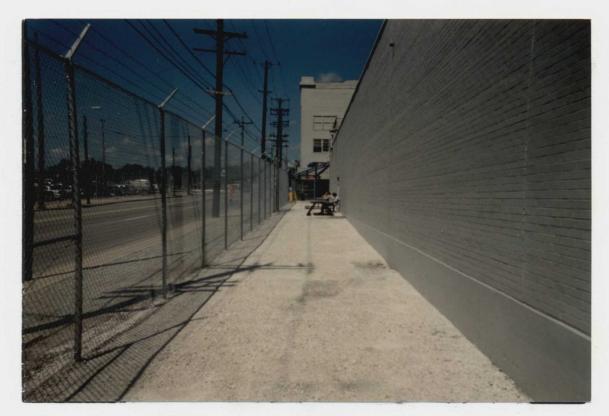
Photo No.: 1 SWMU No.: 1
Date: 08/29/90 Time: 14:00 Direction Facing: N
Description/Comments: Solvent storage tank area showing excavation area west of Building 12.

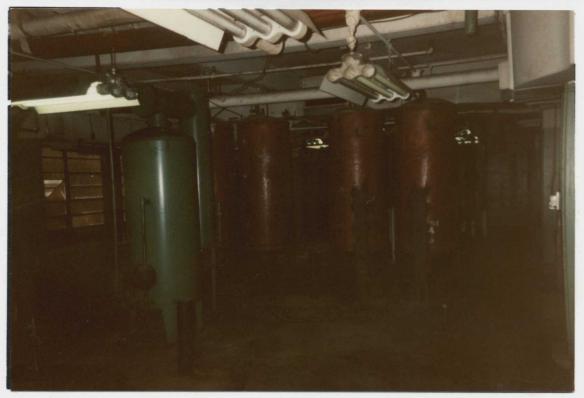
Photo No.: 2 SWMU No.: NA
Date: 08/27/90 Time: 13:40 Direction Facing: N

Description/Comments: Still room showing red chlorinated solvent sample tanks and green Stoddard solvent stills.

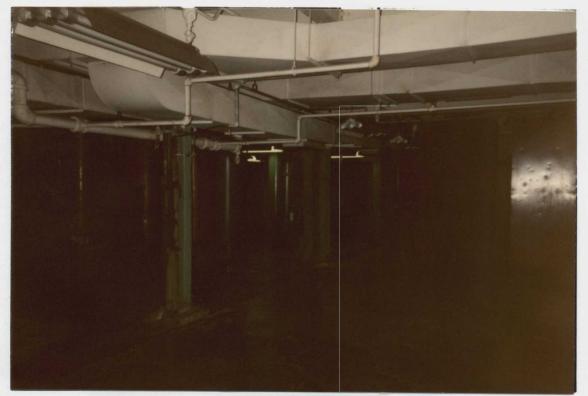
Photo No.: 3 SWMU No.: NA
Date: 08/27/90 Time: 13:40 Direction Facing: SE

Description/Comments: Still room showing red chlorinated solvent sample tanks on left and Stoddard solvent sample tanks on right.

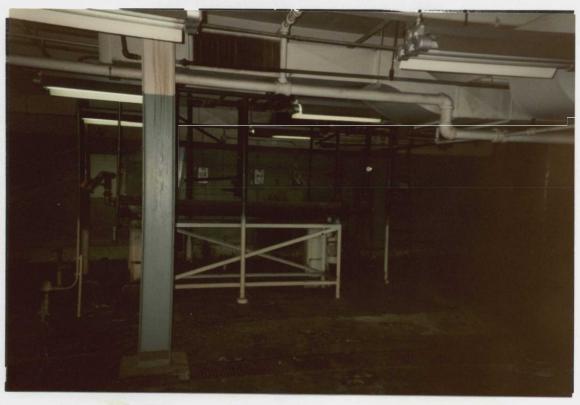
Photo No.: 4 SWMU No.: NA
Date: 08/27/90 Time: 13:40 Direction Facing: E

Description/Comments: Northern portion of still room showing piping and trench.

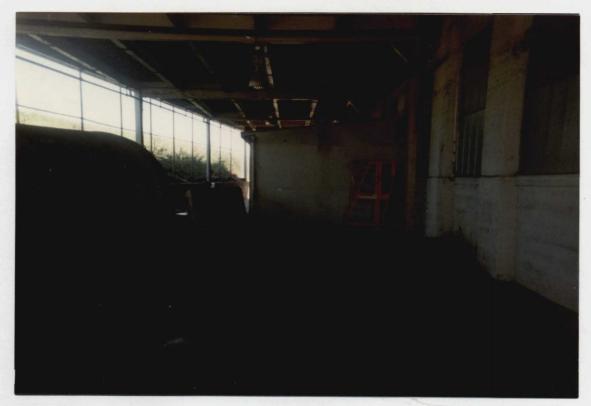
Photo No.: 5 SWMU No.: 5, 6, and 13

Description/Comments: Garage area north of Building 4 showing waste tank and sump; Mad

River levee borders garage area to the north.

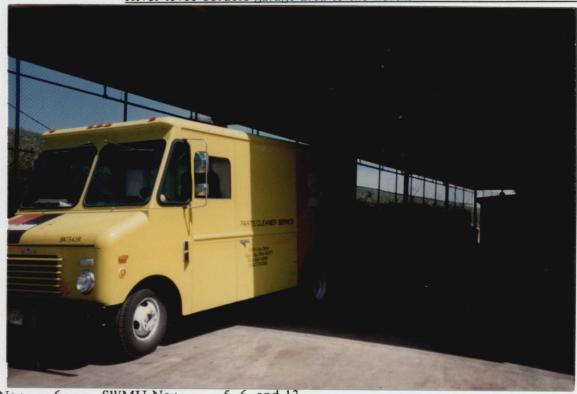
SWMU No.: 5, 6, and 13 Photo No.: 6

tank; Mad River levee borders garage area to the north.

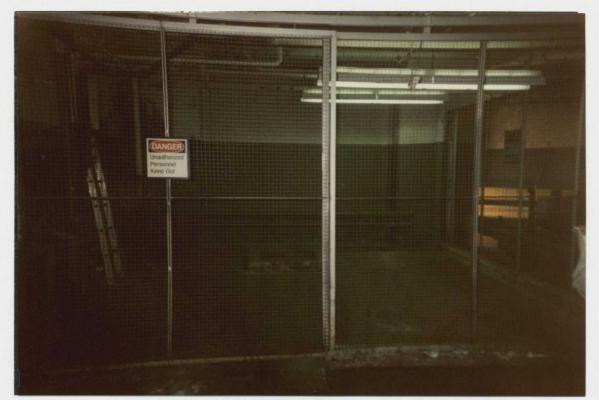
Photo No.: 7 SWMU No.: 7
Date: 08/27/90 Time: 15:00 Direction Facing: S
Description/Comments: Former hazardous waste storage cage in Building 5.

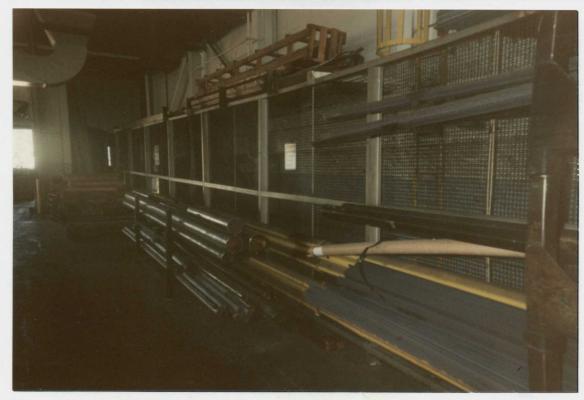
Photo No.: 8 SWMU No.: 8
Date: 08/27/90 Time: 14:50 Direction Facing: N
Description/Comments: Former hazardous materials storage cage area on second floor of Building 24.

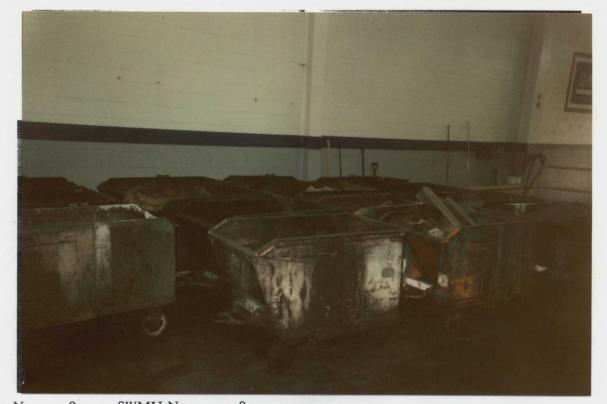
Photo No.:  $\frac{9}{08/27/90}$ Description/Comments:

Time: 13:35 Direction Facing: N
Former hazardous materials staging area adjacent to northern wall of Building 24; area currently used to store nonhazardous scrap materials and machine tailings.

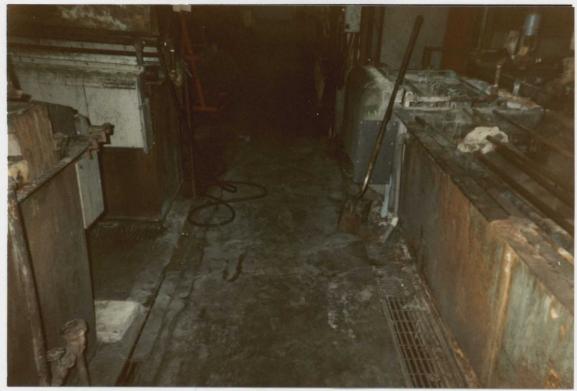
Photo No .: 10 SWMU No.: 10

Time: 15:30 Direction Facing: S
Drains in plating area leading to plating waste sump in Building 9. Date: 08/29/90Description/Comments:

The zinc- and tin-plating of various air conditioning compressor parts takes place in Building 9 (Photo No. 10). This area also houses a paint-stripping operation in which hangers used to carry compressors during painting are stripped with an alkaline cleaner.

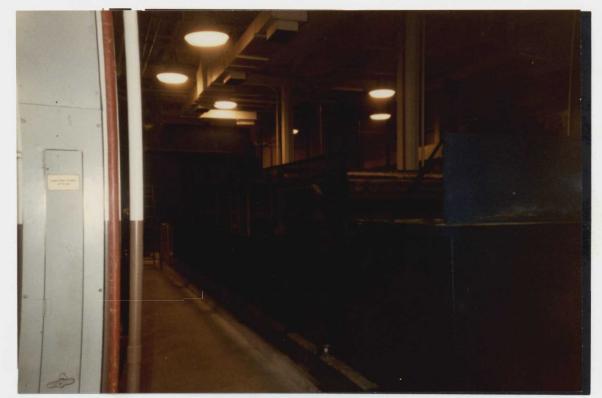
Photo No.: 11 SWMU No.: 11

Description/Comments: Wastewater treatment plant - dissolved air flotation unit on second floor.

Harrison has an on-site wastewater treatment plant (SWMU No. 11) that treats process wastewater, including wastewater from the plating area (Photo Nos. 11 through 20). Treated water from the treatment plant is discharged to the City of Dayton wastewater treatment plant, while dewatered sludge is taken off-site for disposal.

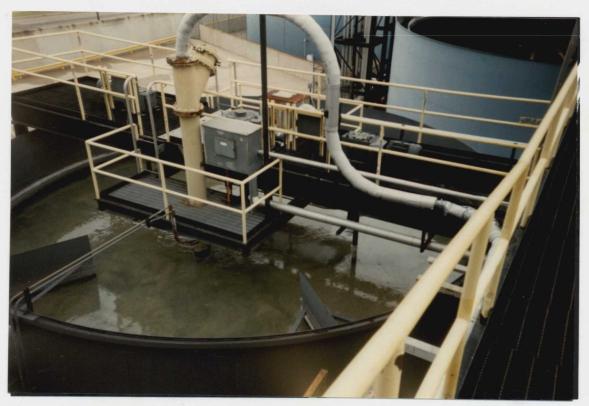
Photo No.: 12 SWMU No.: 11

Description/Comments: Wastewater treatment plant - plating waste treatment tank No. 2; flocculation treatment in progress.

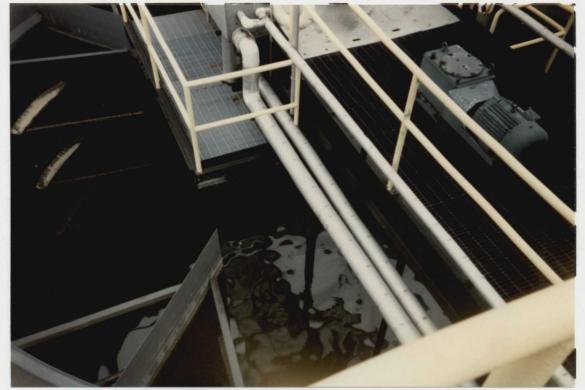
Photo No.: 13 SWMU No.: 11

Description/Comments: Wastewater treatment plant - plating waste treatment tank No. 1.

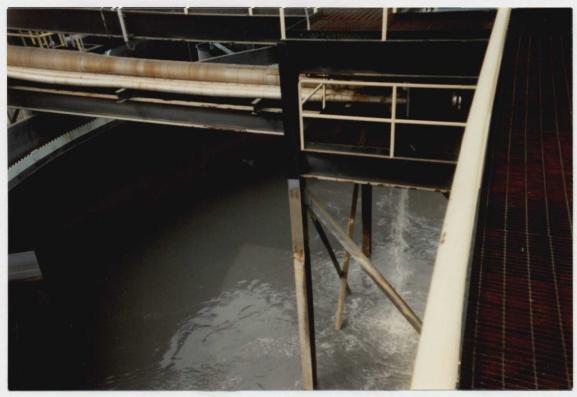
Photo No.: 14 SWMU No.: 11 Date: 08/27/90 Time: 11:30 Direction Facing: W

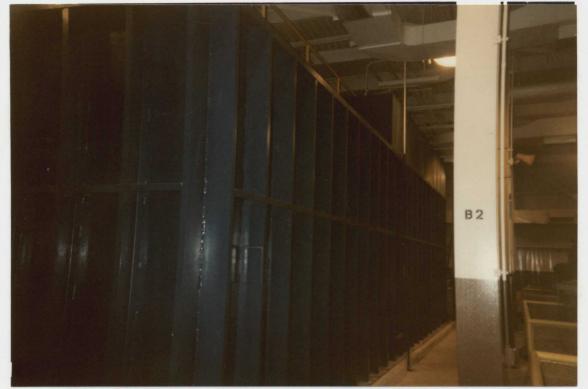
Photo No.: 15 Date: 08/27/90 SWMU No.: Time: 11:35 Direction Facing: N
Wastewater treatment plant - API oil separator on second floor.

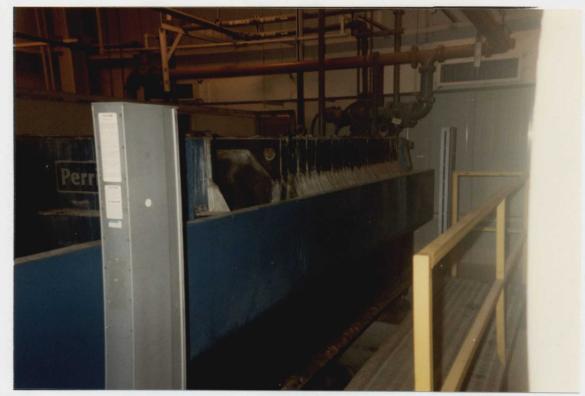
Photo No.: 17 Date: 08/27/90 SWMU No.: 11:45 Direction Facing: SW Time: \_ Wastewater treatment plant - sludge filter press. Description/Comments:

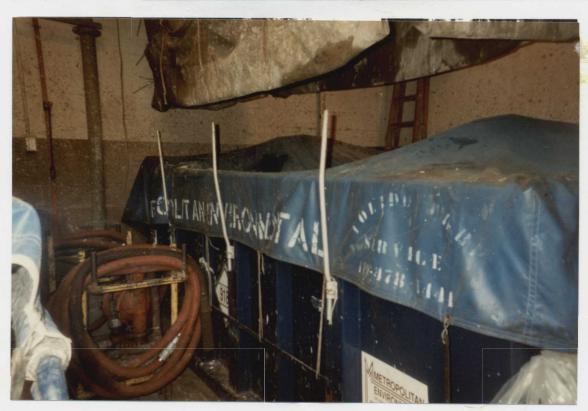
Photo No.:  $\frac{18}{08/27/90}$  S Date:  $\frac{08/27/90}{08/27/90}$  Description/Comments: SWMU No.:

Wastewater treatment plant - sludge accumulation area showing roll-off containers.

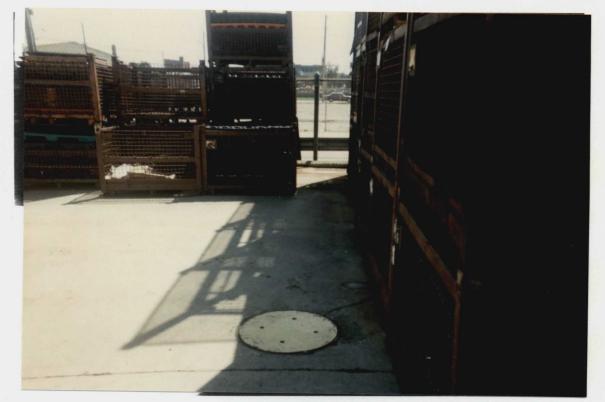
Photo No.: 21 SWMU No.: 12

Description/Comments: Spill interceptor south of Building 12 adjacent to Building 27; NPDES outfall 011 is in background next to Pitt Street.

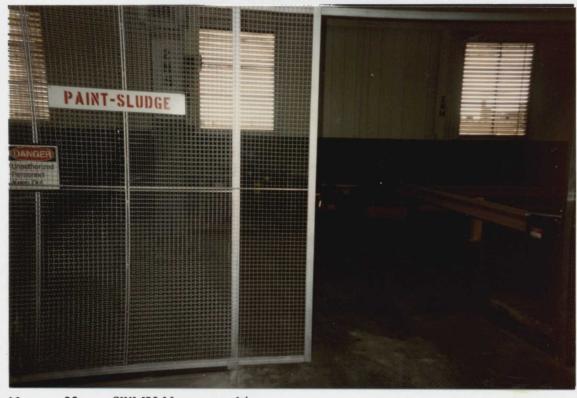
Photo No.: 22 SWMU No.: 14

Description/Comments: Hazardous waste storage cage - paint sludge storage area showing dividers and metal strip berm surrounding area.

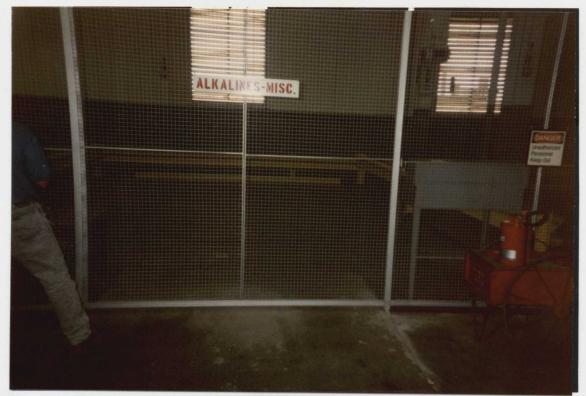
Photo No.:  $\frac{23}{08/27/90}$  S

showing ramp at entrance.

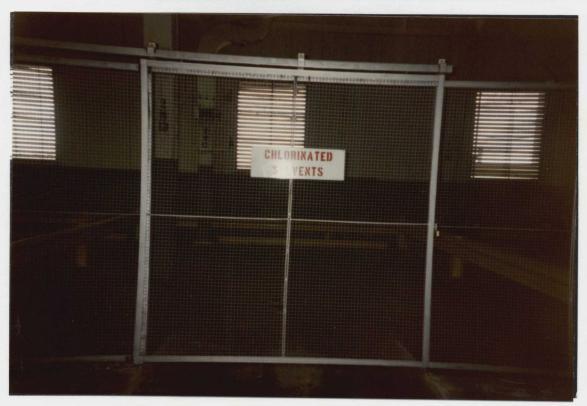
MU No.: 14
Time: 14:50 Direction Facing: S
Hazardous waste storage cage - chlorinated solvent storage area. Photo No.: 24 S Date: 08/27/90

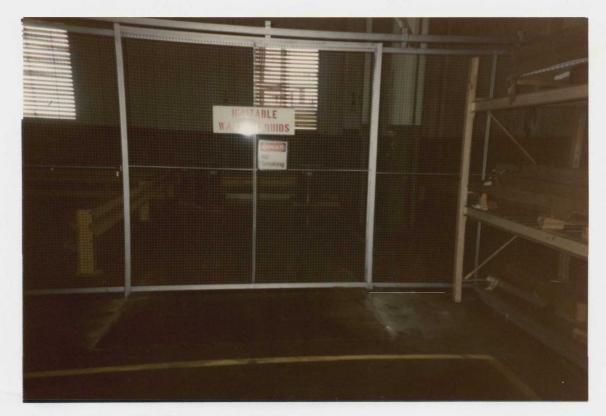
Photo No.: 25 SWMU No.: 14

Description/Comments: Hazardous waste storage cage - ignitable waste liquid storage area.

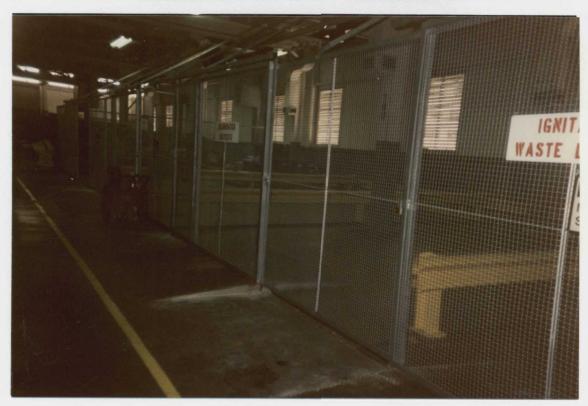
Photo No.: 26 SWMU No.: 14
Date: 08/27/90 Time: 14:55 Direction Facing: SE
Description/Comments: Hazardous waste storage cage showing all four storage areas.

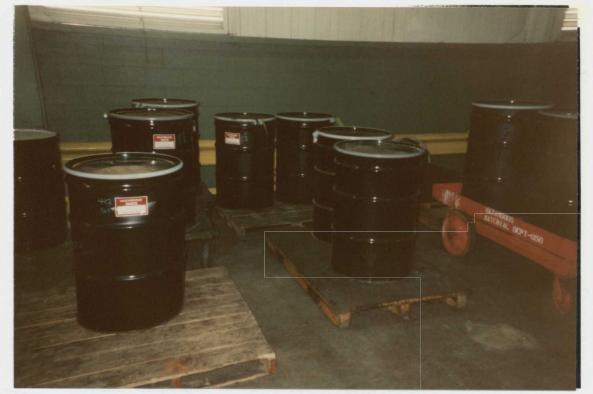
Photo No.: 27 Date: 08/27/90 SWMU No.: Time: 14:55 Direction Facing: S Hazardous waste storage cage - drums in waste paint storage area. Description/Comments:

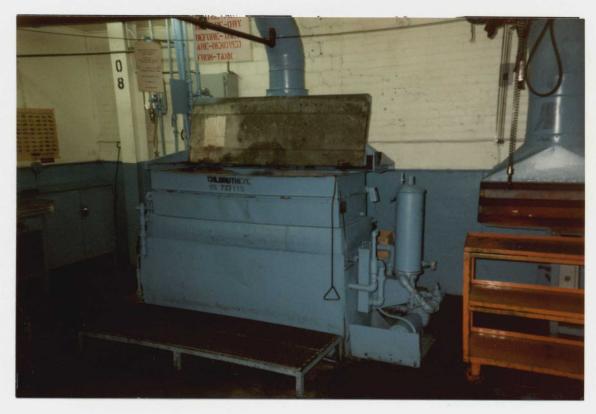
SWMU No.: Time: Photo No.: 28 Date: 08/29/90

MU No.: 17
Time: 14:40 Direction Facing: S
Degreasing unit containing 1,1,1-trichloroethane in Building 22. Description/Comments:

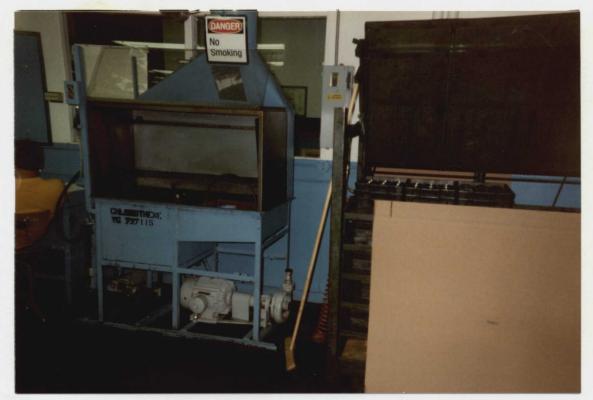
Photo No.: 29 SWMU No.: 17
Date: 08/27/90 Time: 14:40 Direction Facing: N
Description/Comments: Degreasing unit containing 1,1,1-trichloroethane in Building 22.

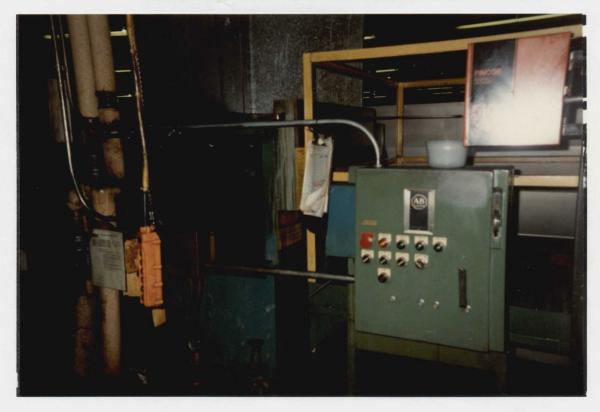
Photo No.: 30 SWMU No.: 17
Date: 08/27/90 Time: 15:20 Direction Facing: N
Description/Comments: Elevated degreasing unit containing 1,1,1-trichloroethane in Building 9.

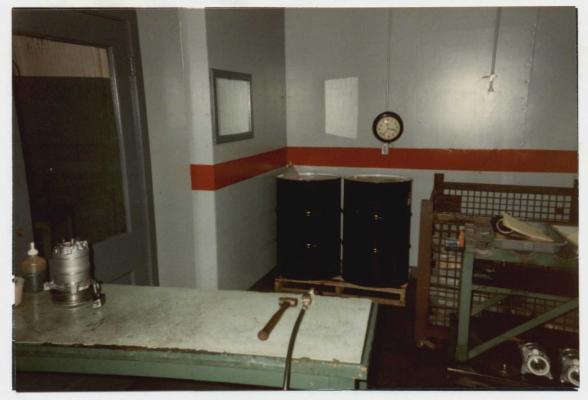
Photo No.: 31 Date: 08/27/90 SWMU No.: Time: Time: 15:50 Direction Facing: N

Quality assurance laboratory - drum on right contains used 1,1,1trichloroethane from degreasing operation; compressor in foreground. Description/Comments:

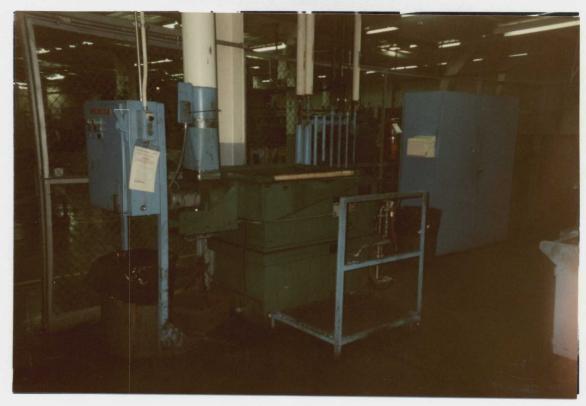
SWMU No.: Photo No.: 32 Date: 08/27/90

Degreaser unit containing Solvo-Clean in Building 24. Description/Comments:

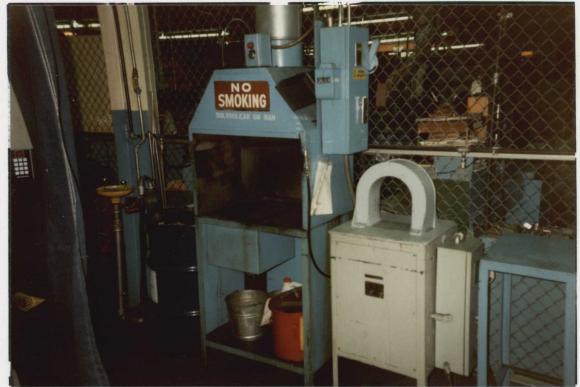
Photo No.: 33 Date: 08/27/90 SWMU No.: 17 Time: 15:45 Direction Facing: N
Degreaser unit containing Solvo-Clean in Building 7. Description/Comments:

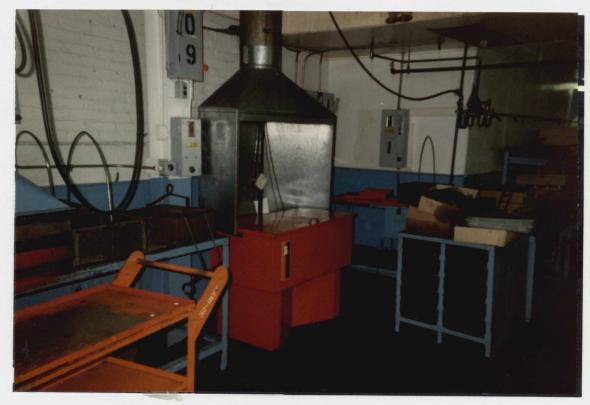
Photo No.: 34 Date: 08/27/90 SWMU No.: 18 14:40

Description/Comments: Safety-Kleen cleaning unit containing petroleum naphtha in Building 22.

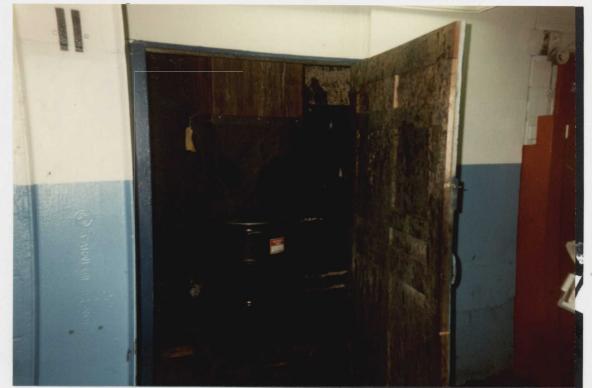
Photo No.: 35 Date: 08/27/90 SWMU No.: Time: 14:40 Direction Facing: E
Paint sludge accumulation drum in Building 12. Description/Comments:

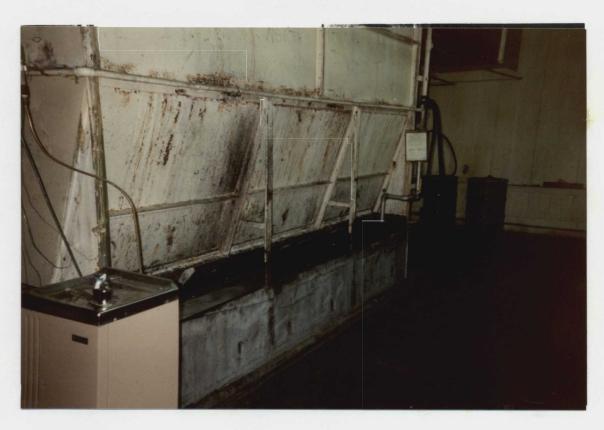
SWMU No.: Time: Photo No.: 36 Date: 08/27/90

Time: 14:45 Direction Facing: SW Paint sludge accumulation unit on second floor of Building 12.

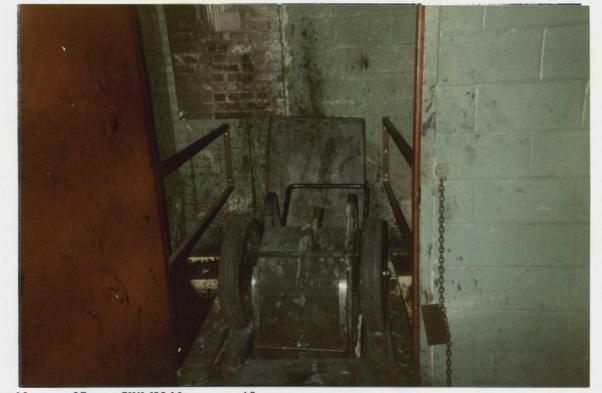
Photo No.: 37 Date: 08/27/90 SWMU No.: 14:45

Time: 14:45 Direction Facing: E
Paint sludge dump area on second floor of Building 12; wheelbarrow used Description/Comments: to transport sludge from accumulation unit to drum one floor below.

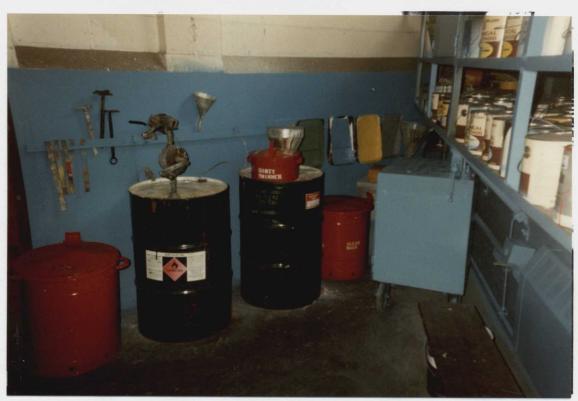
Photo No.: 38 Date: 08/27/90 SWMU No.:

Room adjacent to maintenance paint booth area in Building 10 showing Description/Comments: clean paint thinner drum on left and dirty thinner drum on right.

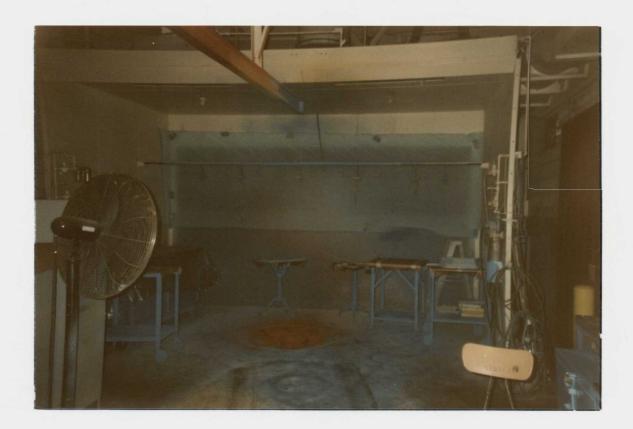
Photo No.: 39 SYDate: 08/27/90 Description/Comments:

SWMU No.: 19
Time: 15:10 Direction Facing: E

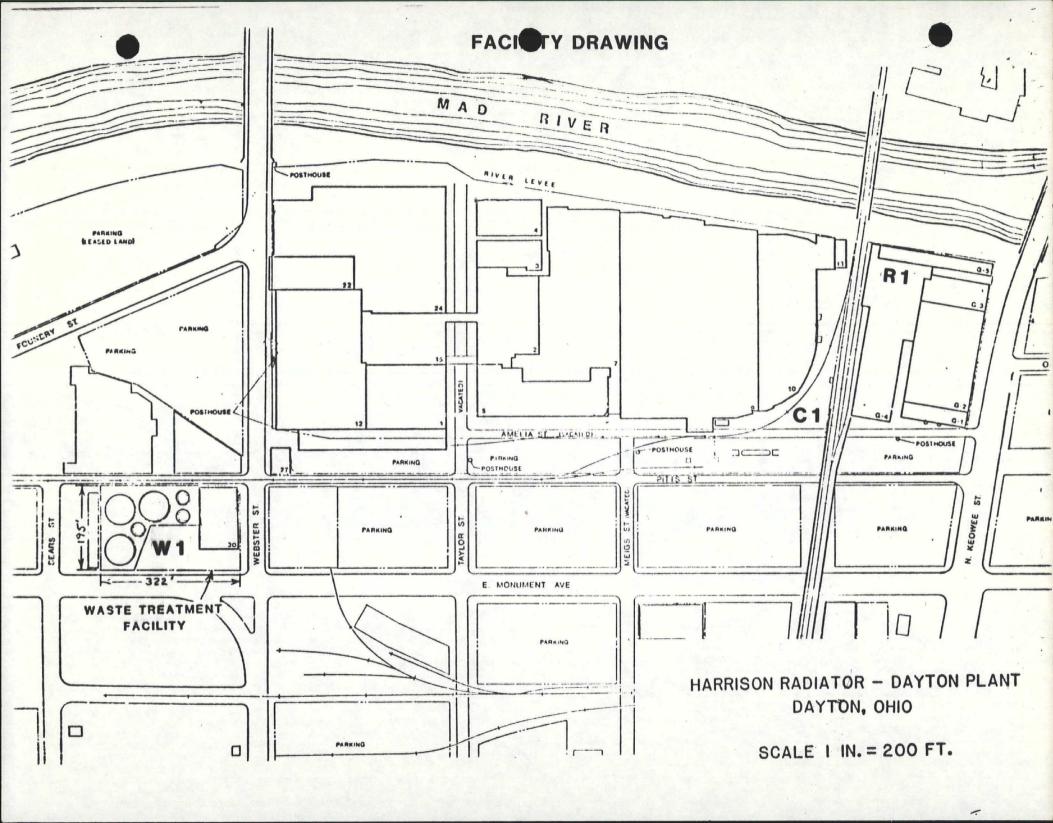
THIS FACILITY BEGAN OPERATIONS IN MAY OF 1981. PROCESS WASTEWATERS ARE SEGREGATED IN THE MANUFACTURING PLANT INTO TWO WASTE STREAMS FOR TREATMENT (SEE FIGURE W1 FOR PROCESS DIAGRAM): PLATING WASTE AND GENERAL OILY WASTE. THE PLATING WASTE CONTAINS CHROMIUM, ZINC, AND TIN FROM THE ELECTROPLATING OPERATIONS. THE GENERAL OILY WASTE CONSISTS OF WASTE WATER CONTAINING WATER SOLUBLE COOLANTS AND OILY EMULSIONS WHICH RESULT FROM OR ARE ASSOCIATED WITH THE MACHINING OPERATIONS: ALKALINE SPRAY CLEANING, ELECTROCLEANING, AIRLESS PAINTING, MECHANICAL DEBURRING AND FLOOR CLEANING. NO CYANODIC PROCESSES OR PRODUCTS ARE USED IN ANY SEGMENT OF THE MANUFACTURING OPERATION.

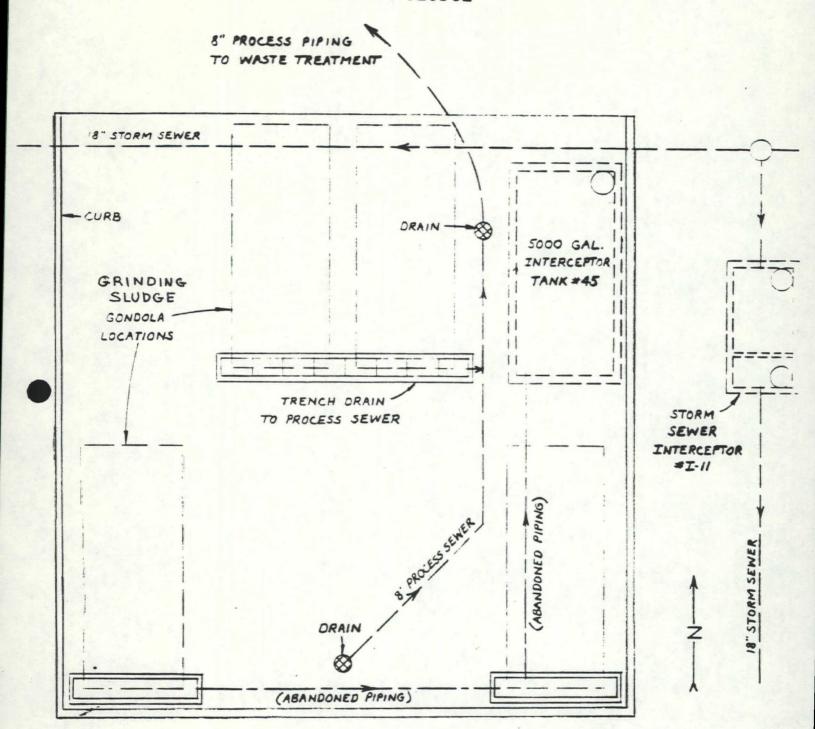
#### WASTE RECYCLING OPERATION

NOTE: ALL AREAS OF PAD DRAIN TO PROCESS SEWER WHICH RUNS TO HARRISON WASTE TREATMENT PLANT; INTERCEPTOR TANK IS NOT CURRENTLY IN USE.
